## Porcelain and Glass Insulators

### Determine the Condition Assessment Value (CAV)

#### Rating Table: Lattice Tower Assessment

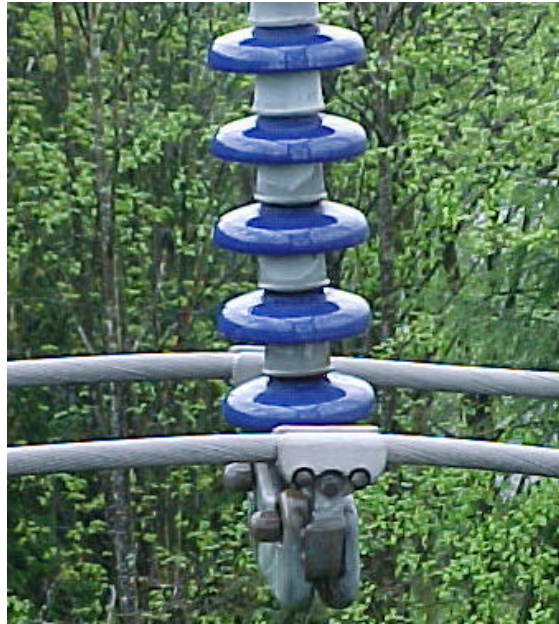
**Fig. A1:** Good or like new

CAV	Condition Description (see photo references)
A	Good or like new.
B	Low degree of damage, wear, decay. Minor chips.
C	Moderate degree of damage, wear, decay. Larger chips, cracks, flash or tracking marks, rust stains on metal parts.
D	High degree of damage, wear, decay. Part or all of shell missing, power arc or lightning damage, rust pitting of metal, cotter keys crushed or disengaged.
E	Completely failed or no longer functional.

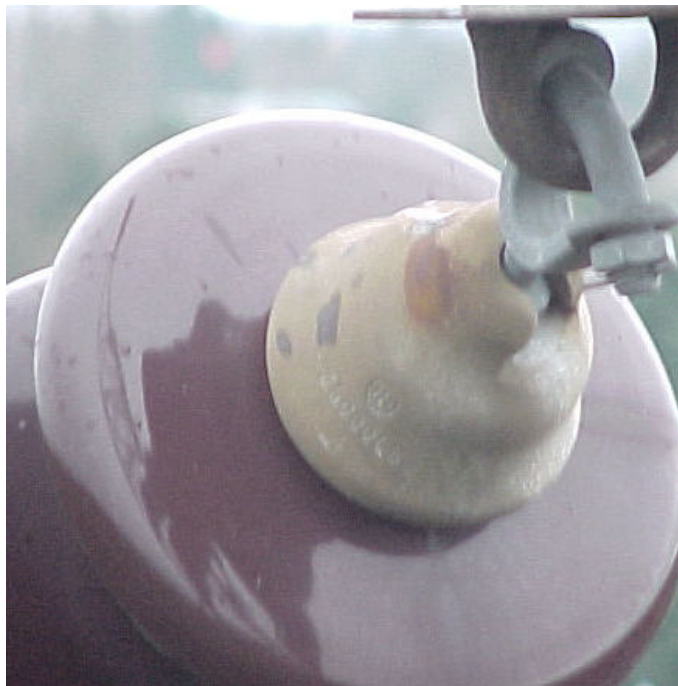
**Fig. A2:** Good or like new
